Battery Safety

CECOM

Directorate of Safety Risk Management

Battery Safety Topics

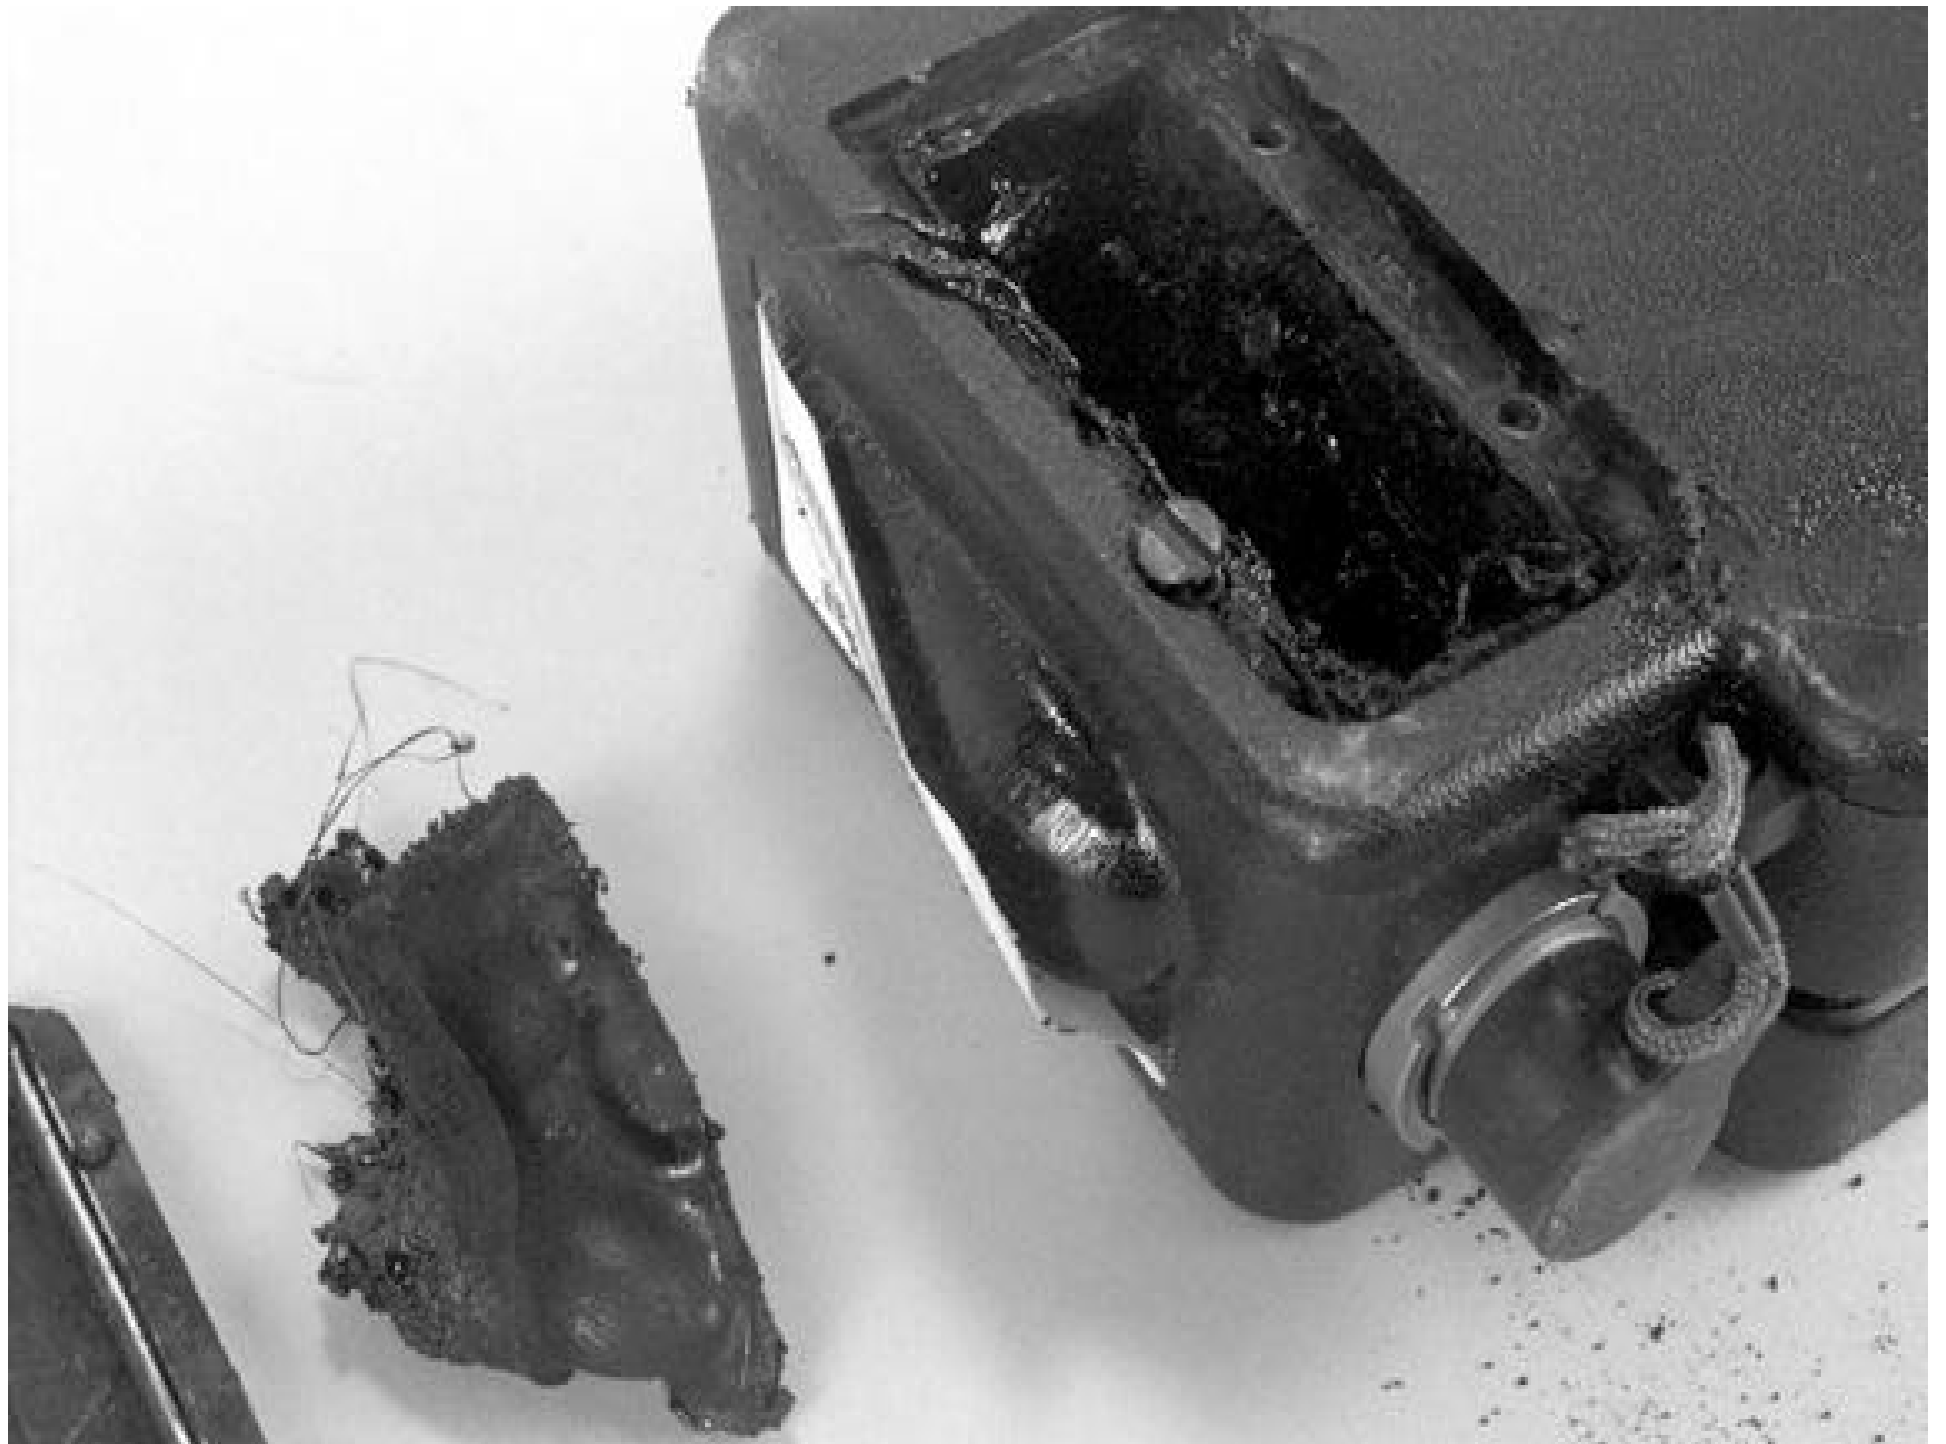
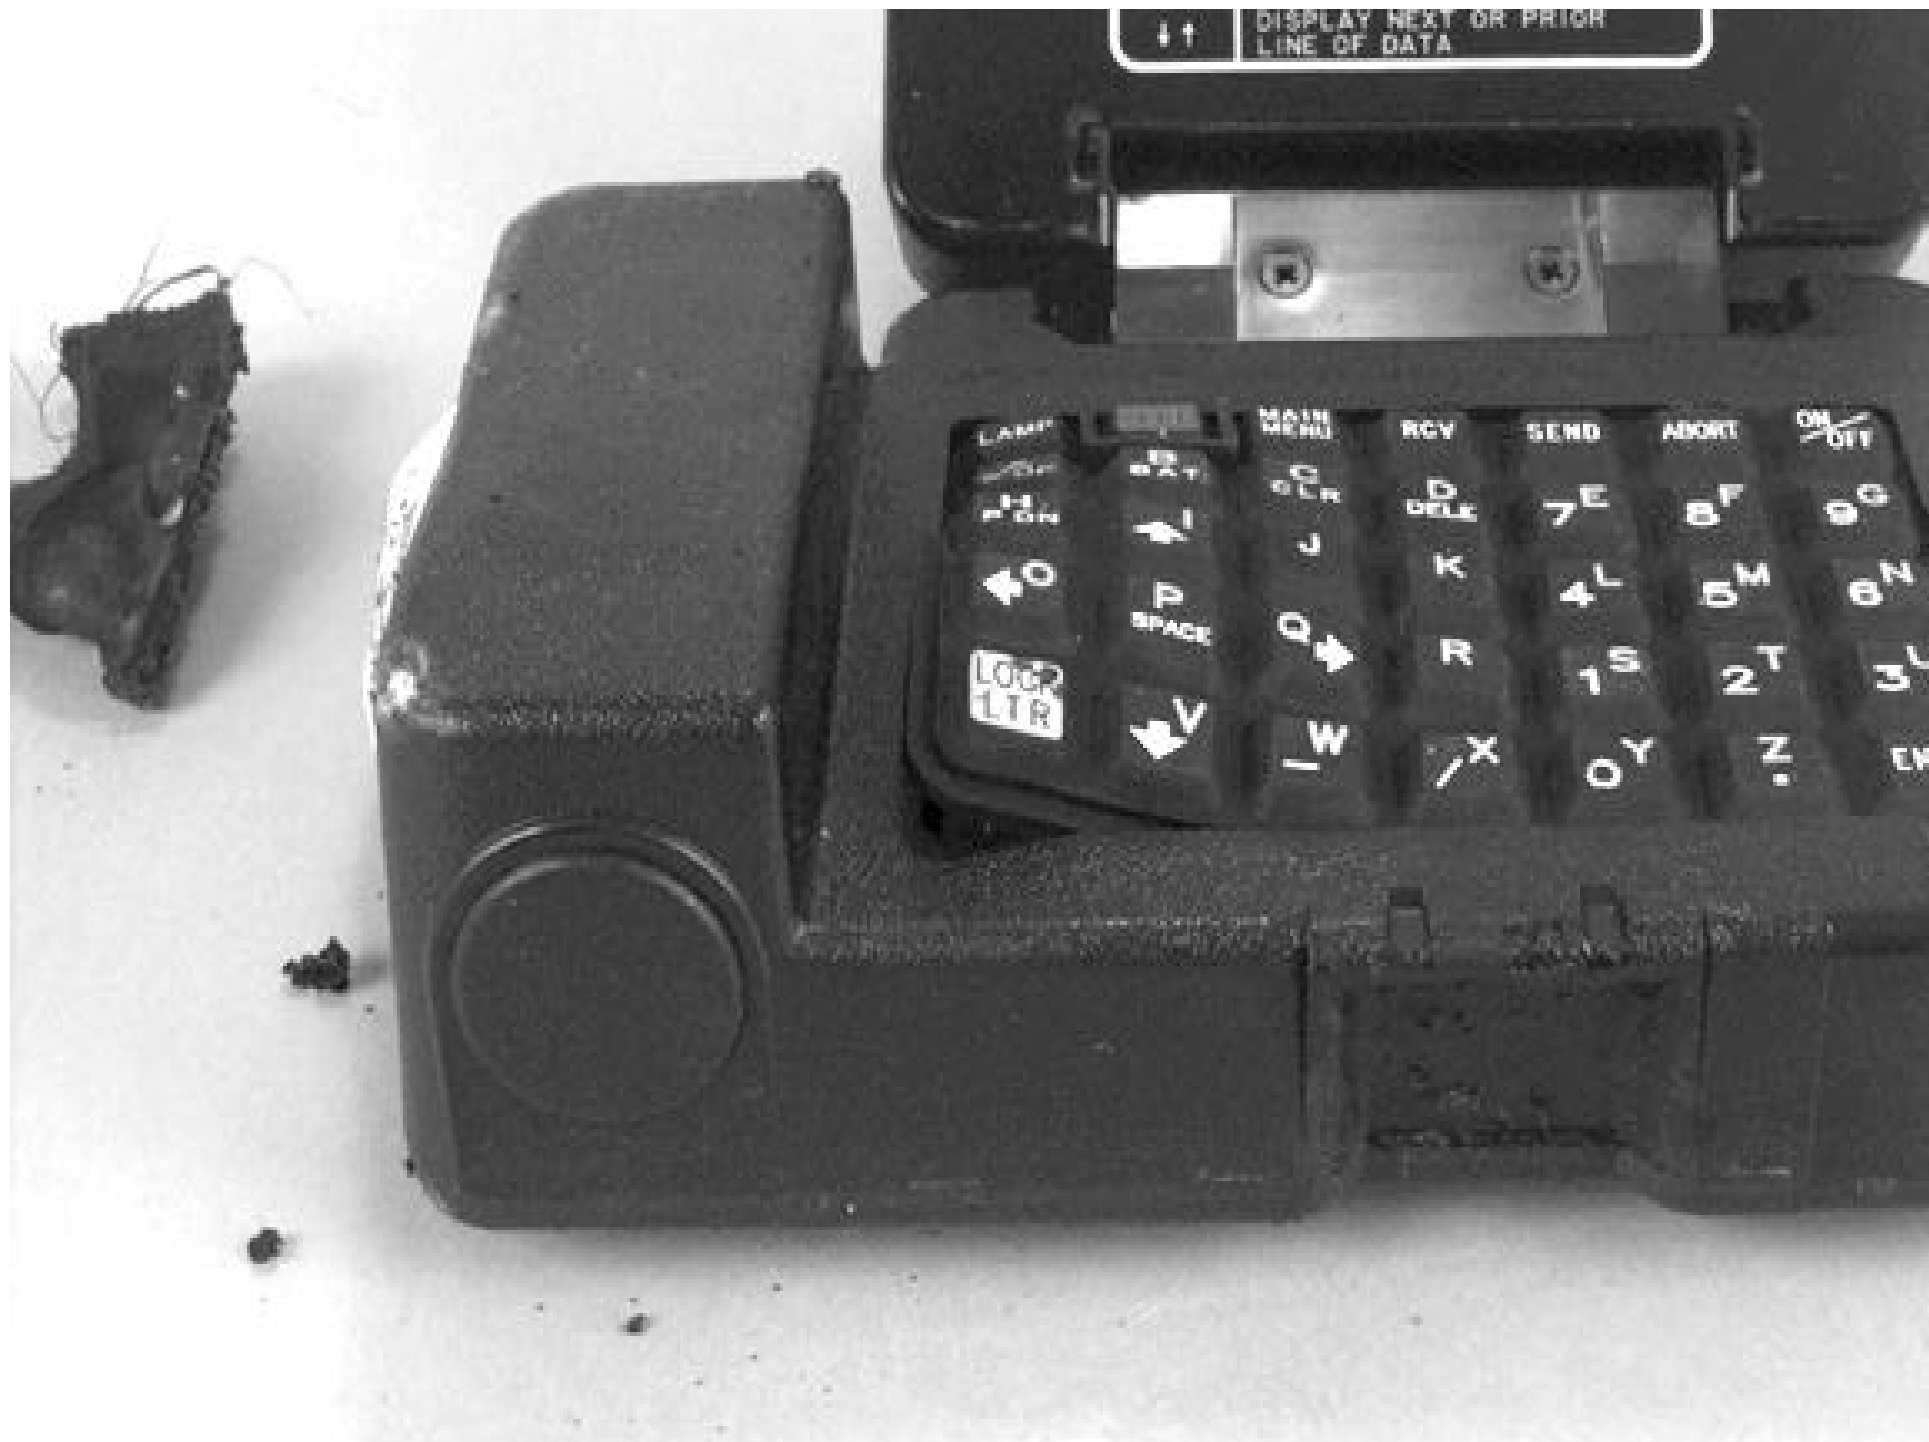
DTD/ANCD (CYZ-10) Incident

- The equipment uses three BA-5123/U or one 9v battery. These are the only authorized batteries for use in the CYZ-10
- BA-5372/U batteries were incorrectly installed in the equipment resulting in excessive heating and equipment damage
- The BA-5372/U fits in the equipment, BUT, it has the wrong polarity and higher voltage!
- Recommendations: Ensure labels affixed to battery compartments identifying proper batteries and address in TM's
